EAST GWILLIMBURY GO STATION

The 30,000 sq. ft. parking lot was successfully installed with Unilock's permeable Ecoloc paving stones.

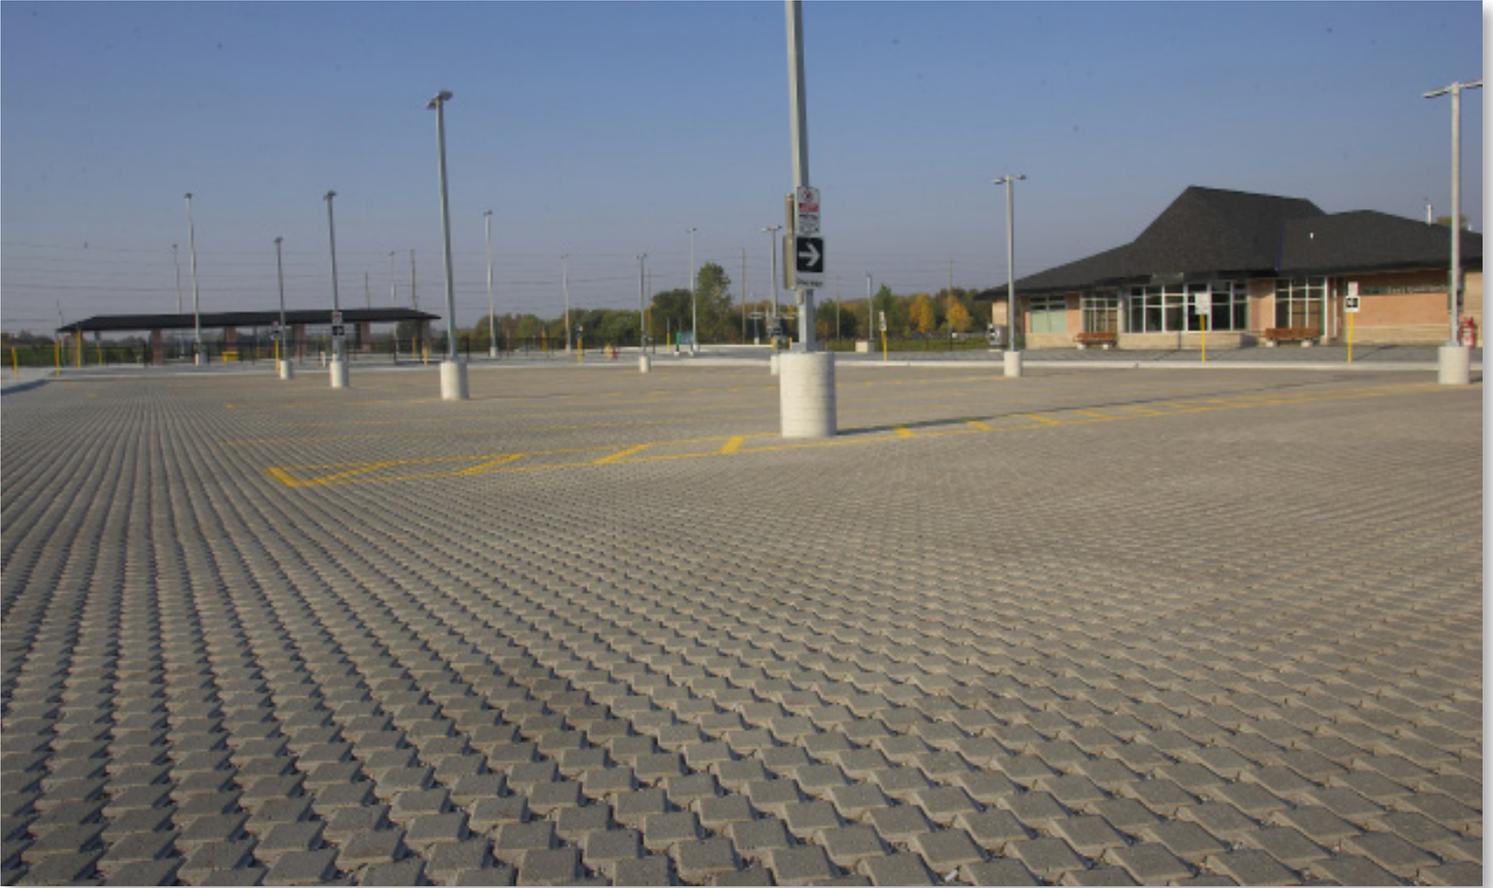
The contracted installer, Premier Interlocking, used an asphalt spreader to place 50-75 mm of HPB (High Performance Bedding) material, on top of the granular base before mechanically installing the paving stones. The HPB bed facilitates rapid infiltration of rainwater to the granular base below. After all the pavers had been installed and compacted to 'seat' them into the HPB, the voids were filled with the HPB using a power sweeper. After the final sweeping, lines were painted for the 'Kiss & Ride' zone of the parking lot. The entire job was completed with a six man crew in one week and was available for immediate use.

In the base design of this project, the granular sub-base was shaped to allow water to move easily through the loose granular layer to the sub-base and permeate into the sub-base, therefore the melting snow on the pavers was able to drain immediately and dry the surface, eliminating the pools of water.

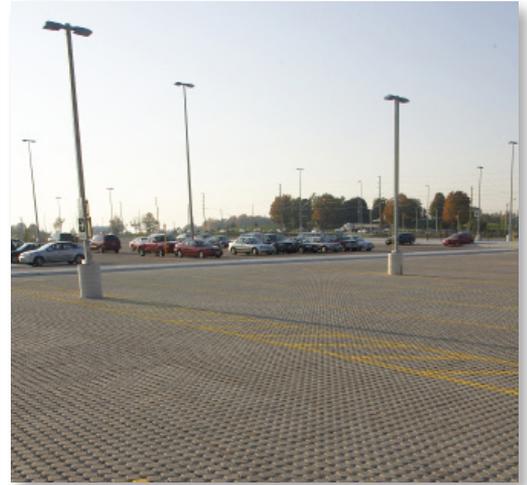
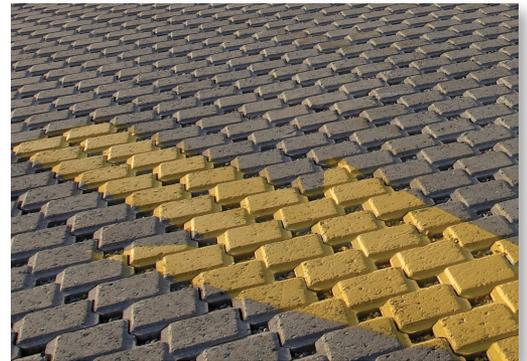
In instances where there is heavy rainfall and the water cannot move through the granular quickly enough, the tapered sub-base directs the water to a sub-surface drain which discharges into a retention pond.
